Mission: Save a landmark Riverhead church from imminent collapse

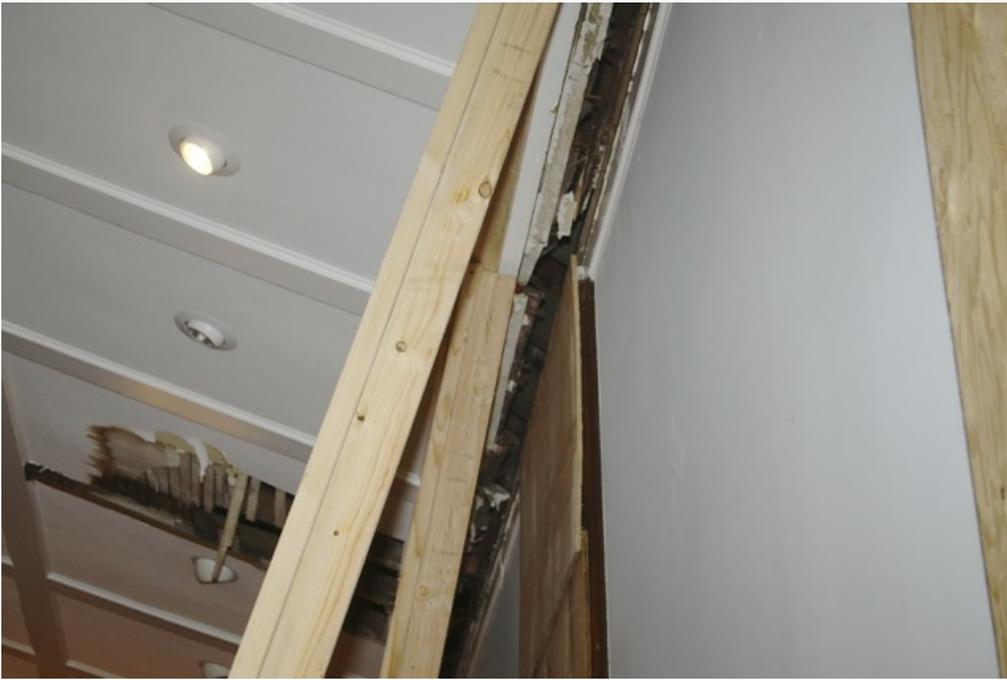
The weight of the failing roof was bearing down and pushing the structure’s two supporting walls out, he explained. Years ago, the church had two concrete buttresses poured to reinforce the west wall. But that put all the pressure and weight of the roof on the east wall, which was not similarly reinforced.

The east wall of the First Congregational Church is being pushed out by the building's collapsing roof. A gap of about six inches between the top of the wall and the ceiling in the church sanctuary results. *Photo: Peter Blas*

The result is visible today in a wall at least six to eight inches out of plumb. There is a gap of a few inches between the top of the wall and the bottom of the roof. It was covered by crown molding.

The leaning east wall will be pulled in — and the roof pushed back up — by solid one-inch steel rods and turnbuckles, Cox said. The steel rods will connect the east and west walls and remain in place.

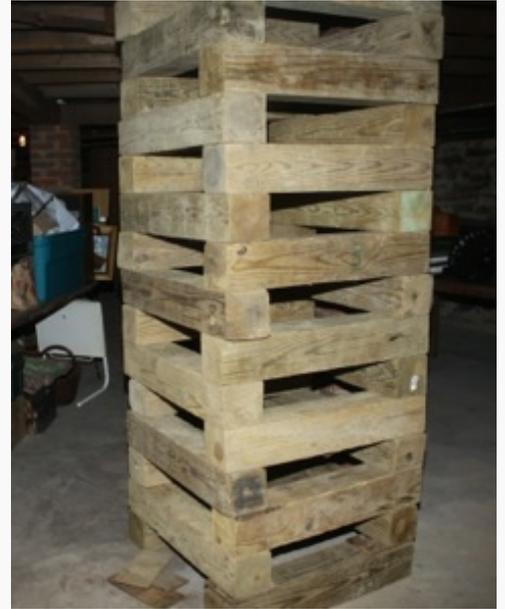
“As I finished putting the last cribbing in place,” Cox said, referring to the four 25-foot-tall wooden support towers built to prevent the roof from caving in, “the ceiling came down and rested on them. Just like that.” He was about to begin shimming the cribbing, to eliminate the small gap between to top of the towers and the ceiling. It turned out to be unnecessary. “It just sort of rested,” he said, incredulous.

He calculated the precise locations of each of the cracked and failing trusses and then began building the cribbing in the church basement. "If we only built it on the main floor of the church, this floor would never support the weight," Cox explained. "We needed to support the structure from the cement slab in the basement up." The four cribbing towers — essentially, pillars — Cox and his crew built extend from the basement to the main floor of the sanctuary and from the main floor to the roof.

Richard Cox is using cribbing, the method he uses to lift houses, to support the roof of the church while stabilization measures are implemented. *Photo: Peter Blasl*

Crews will be building at least four more cribbing towers inside the sanctuary to temporarily lift the collapsing roof up, Cox said. The method is what his specialty construction company, experts in renovating and restoring historic buildings, uses to lift houses.

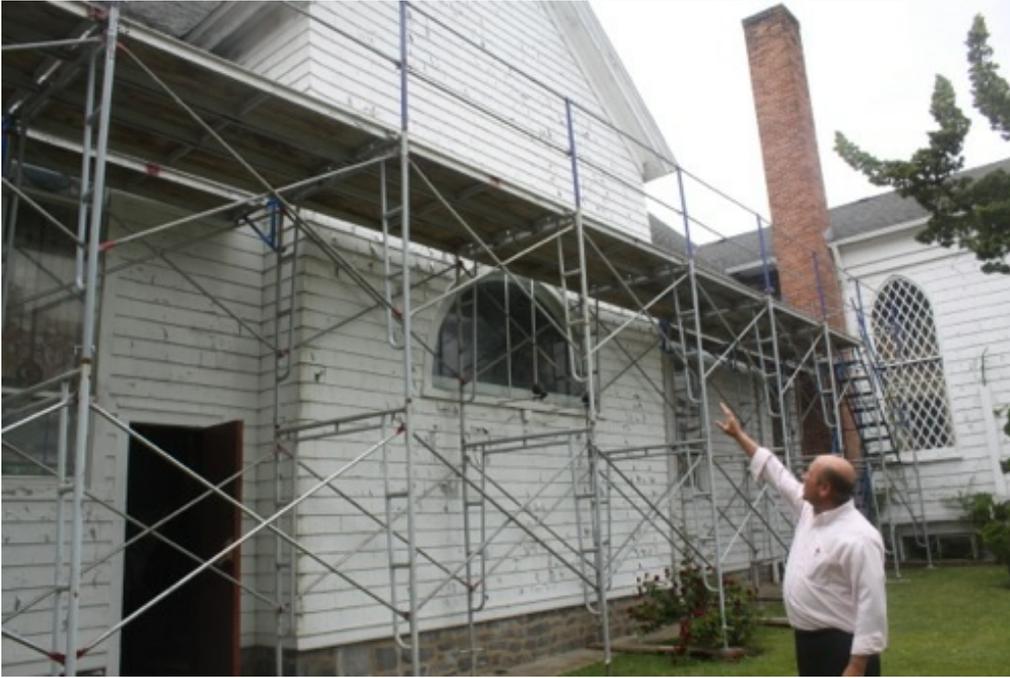
Councilman James Wooten, lifelong member and current chairman of the First Congregational Church of Riverhead, outside the church's east wall, which is being pushed out by the structure's collapsing roof. *Photo: Peter Blasl*
